# Wilcox Crittenden Skipper II Marine Toilet

## On Board Repairs

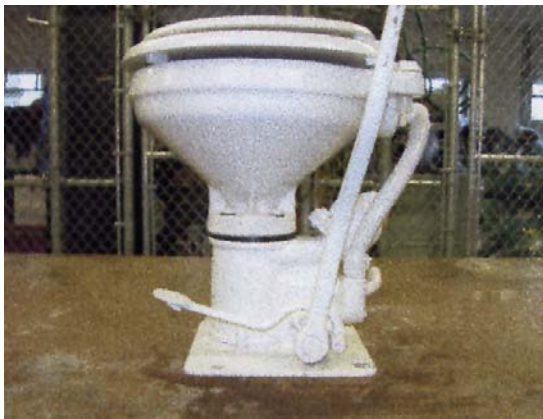
Normal full up position

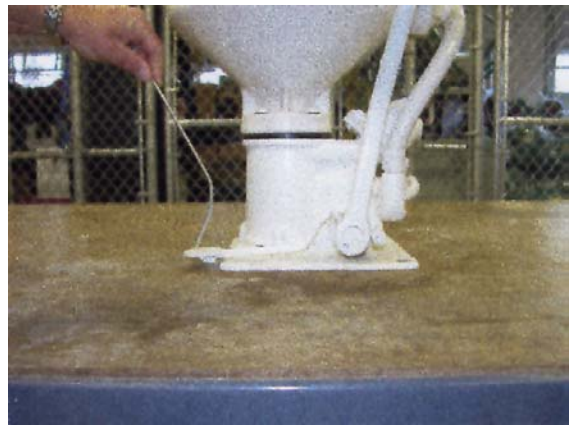
Foot pedal (#39) stays depressed or falls back down and allows sea water to continually flow into the bowl and overflow into the shower sump.

The Flush Control Lever Spring (#17) has weakened through use and is no longer strong enough to keep the foot pedal in the up position.

Normal fall down position

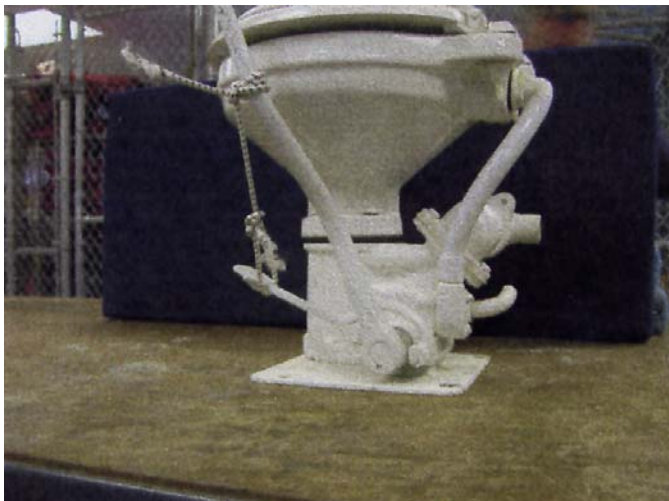
Attached Bungee cord

Do not attempt to repair the spring while underway. Rather use your McGyver ingenuity and attach a bungee or cord to tie the foot pedal in the up position, or secure (close) the seawater intake valve when not flushing the head.

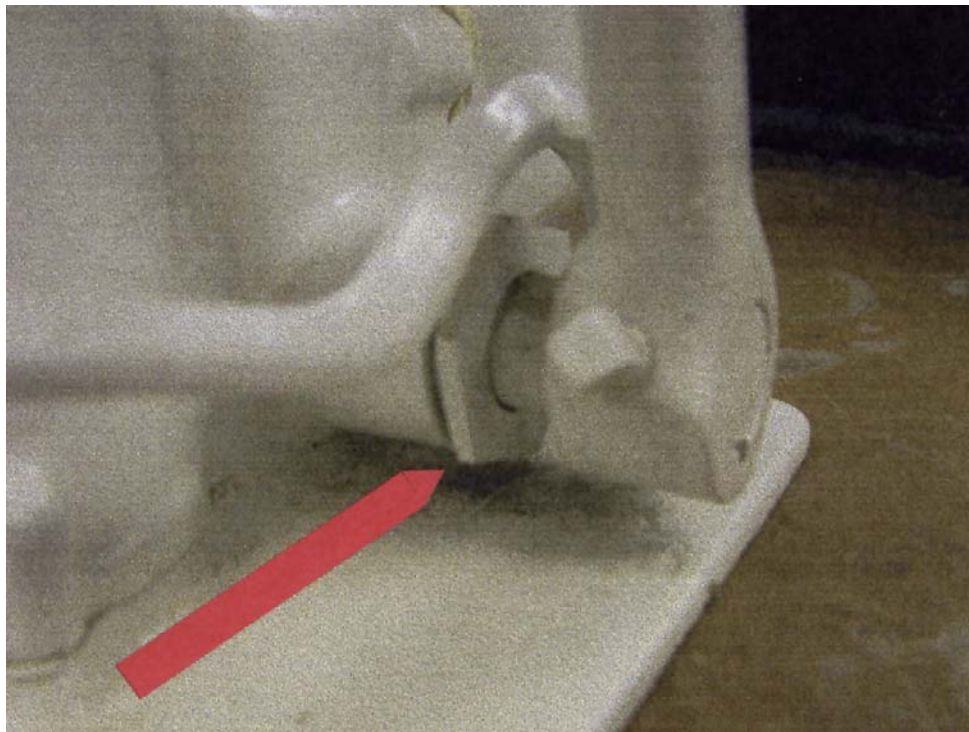
Leaking Pump Shaft Packing Cap (#48)

The threads on the Pump Shaft Packing Cap (#48) are not tight enough to compress the Pump Shaft Packing (#52)

Since the leakage is only uncontaminated seawater, recommend you do not attempt on board repair because you may strip the threads on the cap and exacerbate the problem.

Warning: both the pump Shaft Packing Cap (#48) and the base casting housing (#53) are bronze and if you over tighten the cap, the leak may become severe.

With the warning in mind, you may gently tighten The Shaft Packing Cap (#48) until the leak subsides.

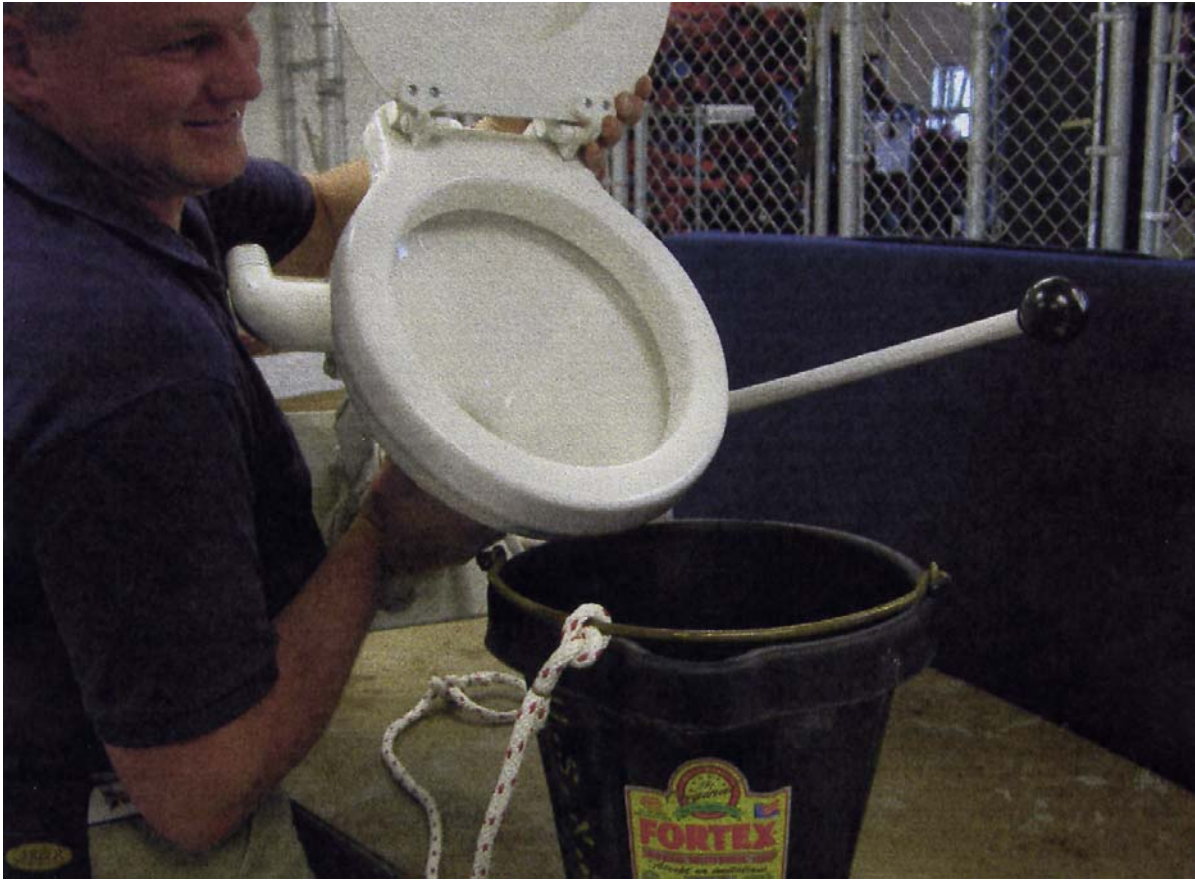
5. Turn head upside down and drain the residual affluent into a bucket.

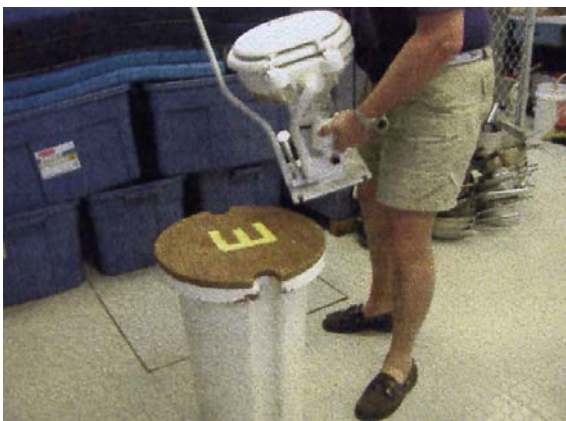
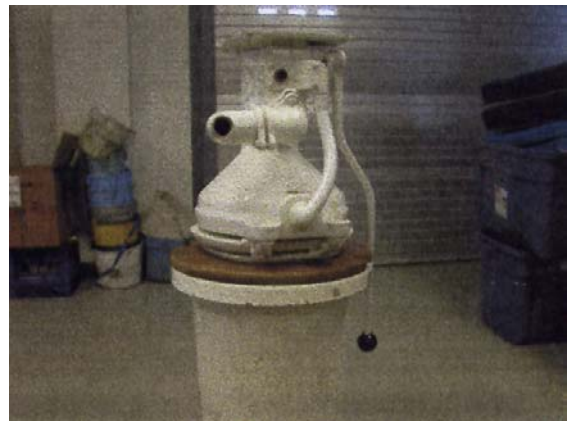
6. Move the drained toilet to the Navy 44 galley area and turn it upside down on the trashcan where you can complete the disassembly as required.

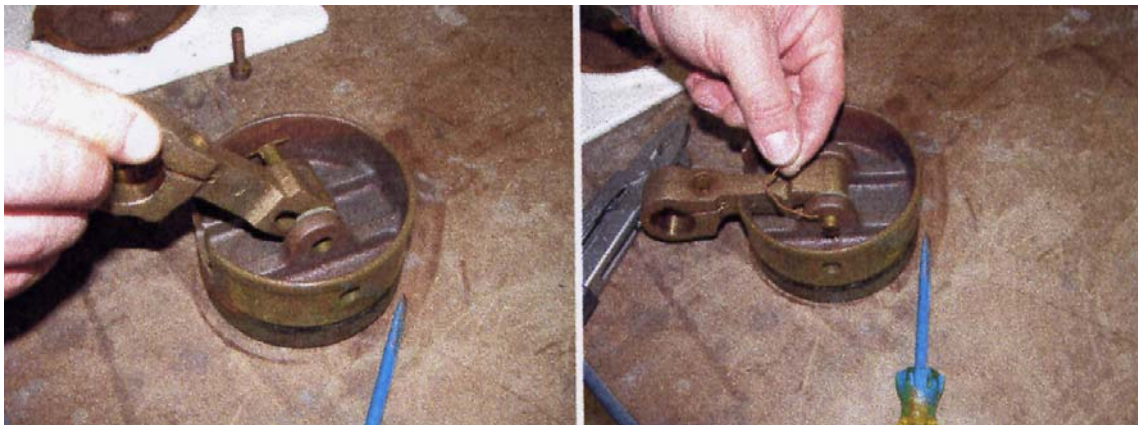
A Cotter Key in the Piston Head Pin (#35) failed allowing the Piston Pin to back out of the Piston Lever (# 34) partially disengaging from the Piston Head (#37). This prevents full travel of the Piston Head (#37) and therefore fails to remove fluid from the bowl.

Remove the toilet from the Head Compartment and disassemble in accordance with the instructions outlined in the Removing the Toilet From the Head Compartment and Final Disassembly sections. Replace the Cotter Keys as required with non-magnetic (bronze or brass) keys (pins).

If bronze or brass keys are not available, use any key or pin and report the substitution to maintenance personnel upon return. The corrosive effect of saltwater will rapidly deteriorate any magnetic material.

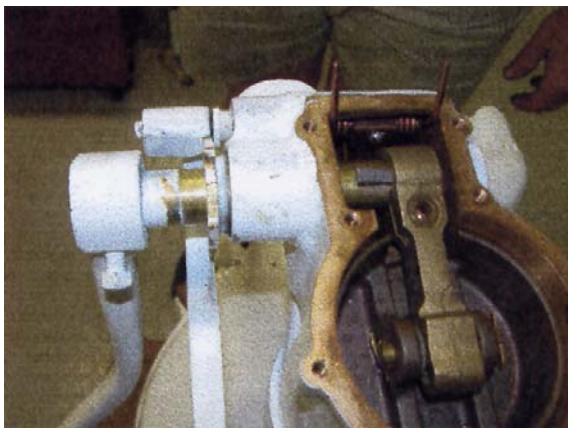
Pump Shaft Key (#50) has slipped out of the shaft because the Piston Lever Screw (#33) was too loose allowing the Piston Lever (#34) to expand permitting the Pump Shaft (#49) to back out of the Base Cast Housing (#53).

Pump shaft backed out  $\frac{1}{4}$  inch with key dislodged.

If you are lucky and the shaft has not backed out more than  $\frac{1}{4}$  inch observed on the shaft scribe mark, then you might be able to reseat the key by lightly tapping on the Pump Shaft Face and easing the shaft back into its housing and reseating the key. If this is successful, you will need to repeat this action as necessary to maintain the shaft in the housing because you will not be able to tighten the Piston Lever Screw (#33) and the Pump Shaft (#49) will continue to back out of the Base Case Housing (#53)

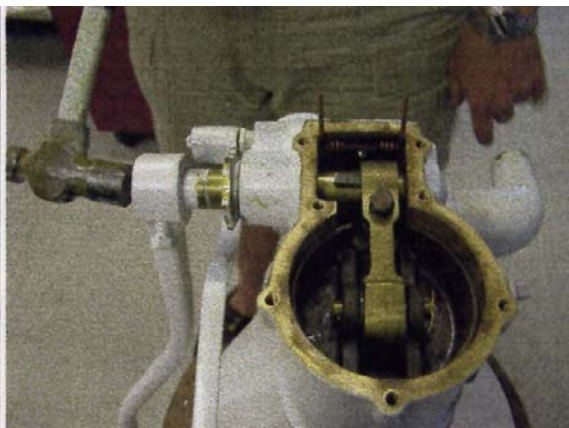
Hammering shaft face

After removing the base plate, loosen the piston lever screw (#33) (do not remove completely) until the shaft moves freely. The key will be in place or lying in the housing. If key is in place but skewed or rocked out of the shaft, reposition the key so it is parallel with the shaft. Lightly tap the Shaft Handle until the Pump Shaft (#49) has been seated back in the Housing (#53). Then tighten the piston lever screw (#33) to firmly hold the shaft. Remember the threads and screw are soft metal and are prone to stripping. You can even break the bolt.

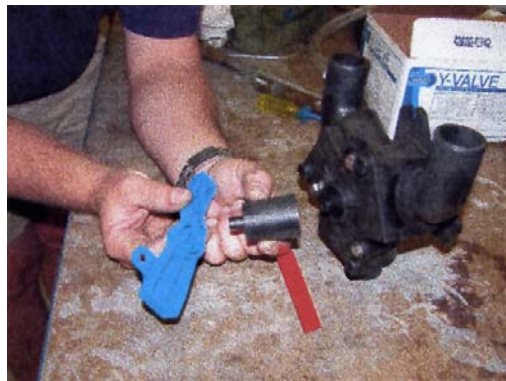
Y-Valve Handle Extension has broken and will not rotate the diverter shaft.

Remove the Handle Retention Screw and replace the Handle Extension. A spare is carried in the maintenance kit.

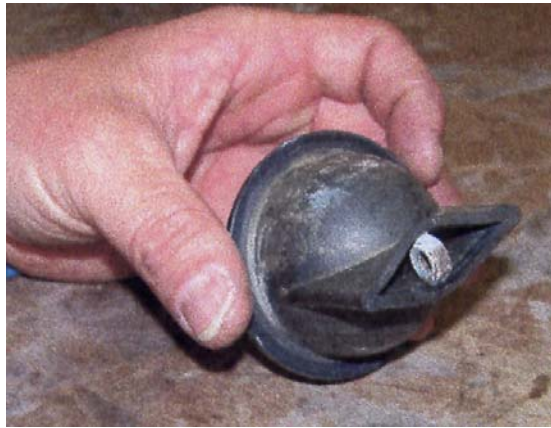
The Joker Valve (#25) functions as a one way check valve. When the duck bill does not fully close, affluent may back flow into the bowl.

Pump the handle vigorously in an attempt to dislodge the item that is holding the duck bill open. If this is unsuccessful, remove the Coupling Flange Bolts (#19).

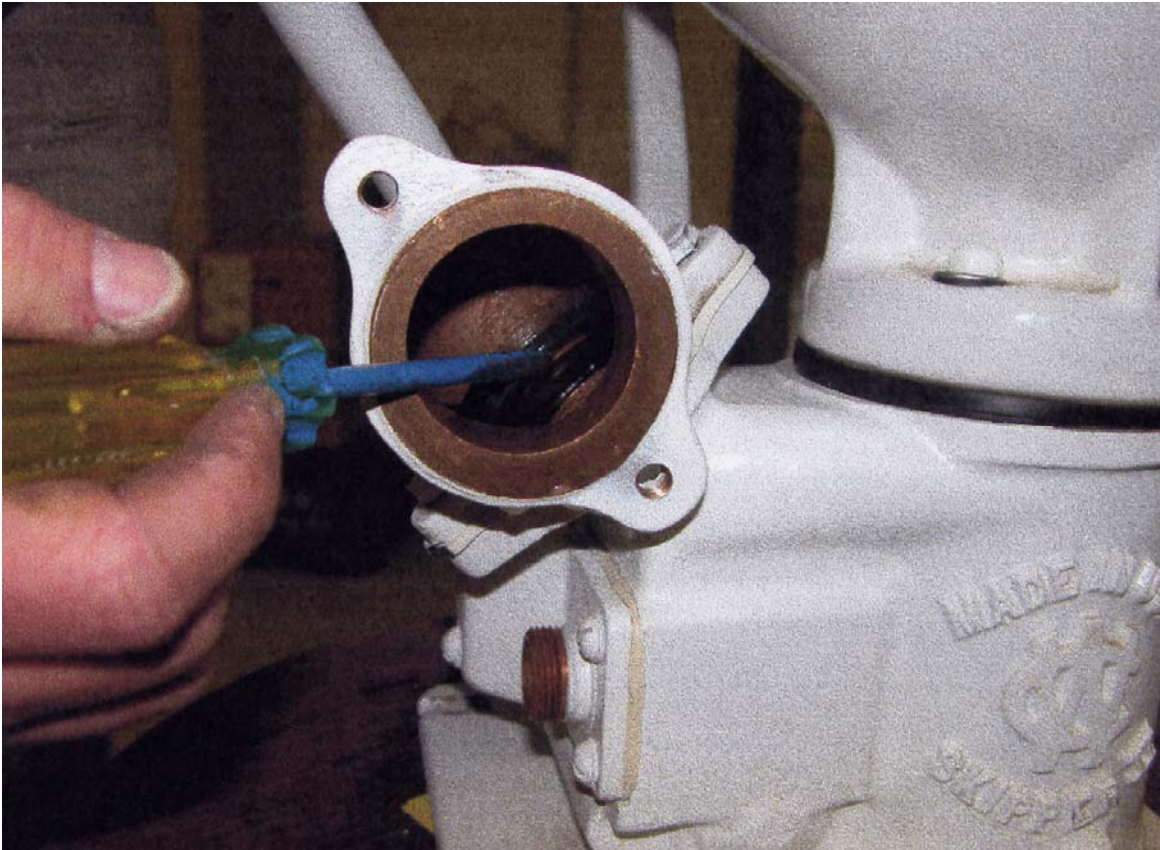
Discharge Flap Valve Assembly (#28) has trapped waste.

Since the 90° Discharge Tailpiece (#22) has already been removed from the Rising Main (#26), you have access to the Discharge Flap Valve Assembly (#28). Inspect and remove the errant material.

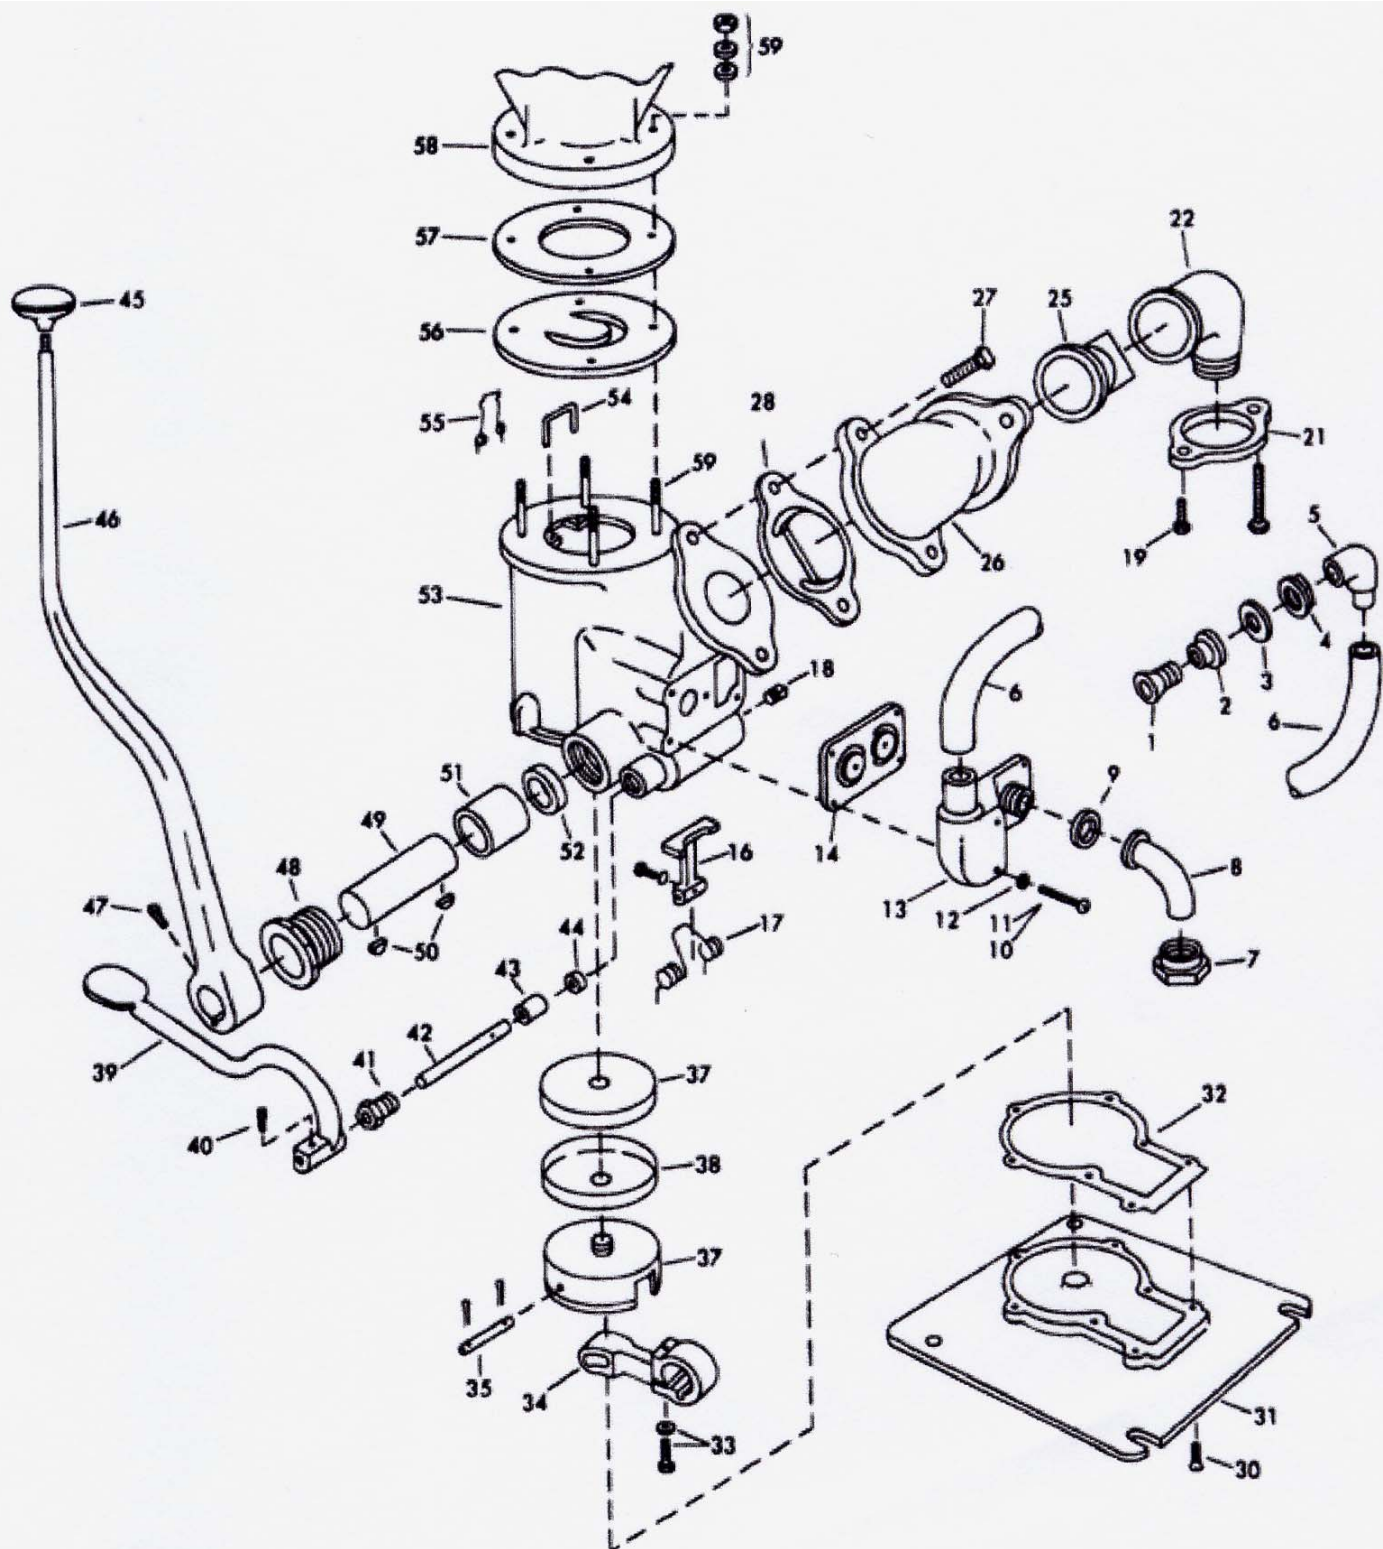
Although the Wilcox Crittenden Skipper II Marine Toilet is relatively reliable, there are occasions that it malfunctions and this document is a set of notes to aid in affecting on board repairs. The parts list and associated illustrated parts breakdown (IPB) are contained in pages 23 & 23. You can identify the parts by comparing the numbers in the parts list with the IPB.
